## CASE STUDY

# Country Club Johannesburg — Rocklands Dam

Country Club Johannesburg, Gauteng

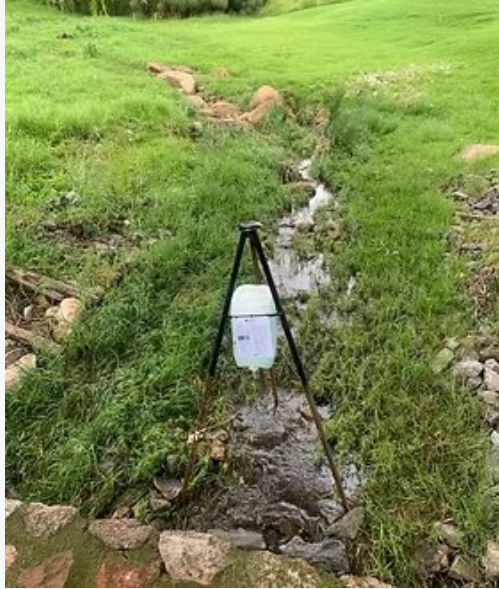
#### ESTATE WATER BODIES, 5 WEEKS AFTER DOSING

Dissolved oxygen (mg/L): Lily Pond Upper 1.8->7.8, Lily Pond Lower 1.8->6.5, Night Heron Dam 4.8->7.0, Irrigation Dam 5.7->7.1, Rocklands 5th hole 4.0->5.1.

- Rocklands Dam had no aeration system installed.
- Six water bodies across the estate were monitored for dissolved oxygen.
- Two ponds (Lily Pond Upper and Lily Pond Lower) were eutrophic with a noticeable odour before treatment.

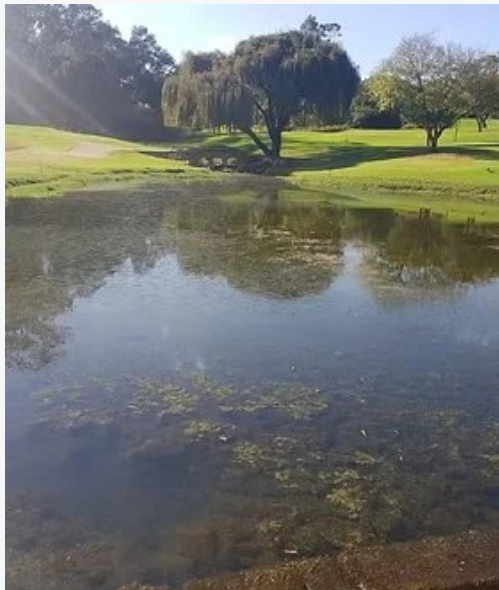
#### ROCKLANDS DAM

94% reduction in E. coli achieved with no aeration installed — biological treatment alone, verified by WATERLAB.

Rocklands Dam E. coli result verified by WATERLAB, a SANAS-accredited laboratory. The dissolved oxygen figures across the six water bodies are on-site instrument readings rather than laboratory
