### WASTEWATER TREATMENT WORKS

# Municipal wastewater works, Highveld — treating a plant with no functioning disinfection or solids return

Highveld region, South Africa

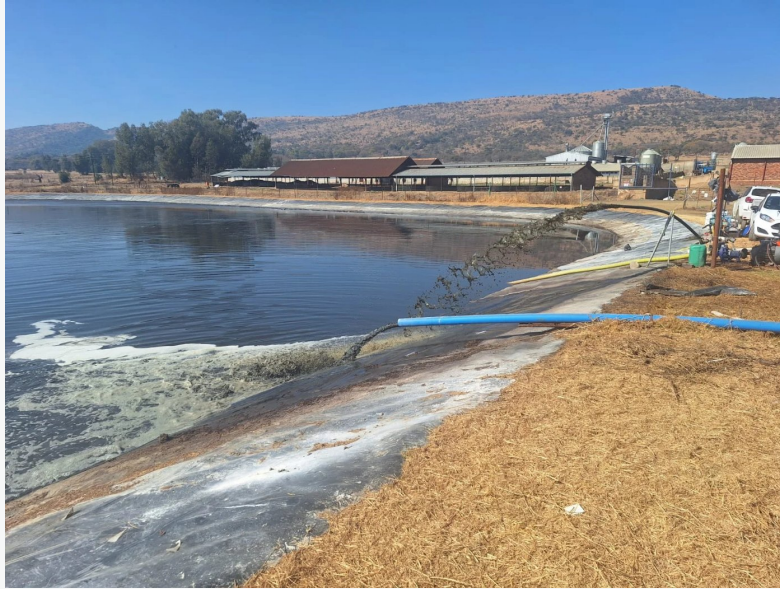
**INLET**

COD 2,903 mg/L, turbidity 1,371 NTU.

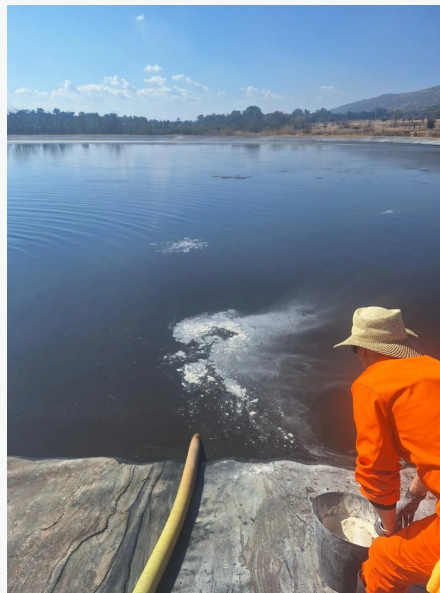
**OUTLET**

COD 181 mg/L (93.8% reduction), turbidity 60 NTU (95.6% reduction).
